GT-2002-30630

**EVALUATING ENVIRONMENTAL BARRIER COATINGS ON CERAMIC MATRIX COMPOSITES
AFTER ENGINE AND LABORATORY EXPOSURES**

ABSTRACT

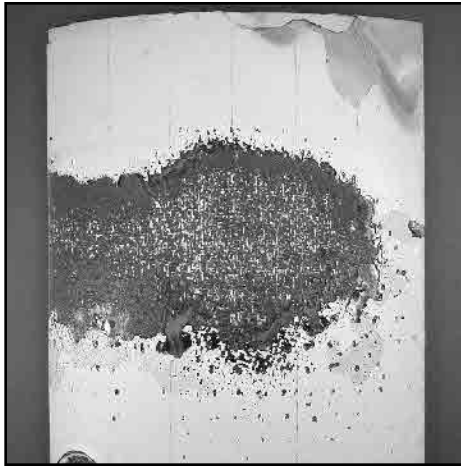
Fig. 3a. Severely damaged area on working surface of inner liner corresponding to a typical fuel injector impingement area.

In areas directly associated with fuel injector impingement (Fig. 3a), corresponding to the hottest areas on the liner surfaces, the loss of EBC due to volatilization was extreme. In fact, most of these localized areas showed evidence of gradual surface recession of the EBC down to the CVD SiC seal coat, which had started to oxidize. In two of the fuel injector impingement areas where the EBC had fully volatilized, oxidation of the CFCC material was evident.

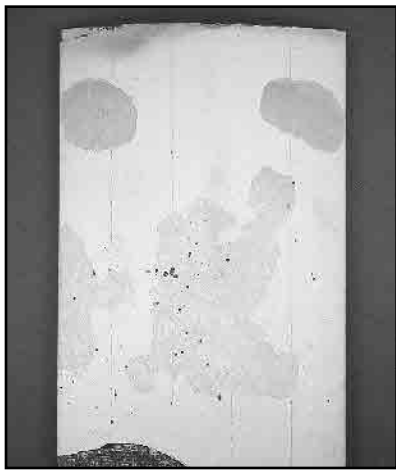
Fig. 3b. Area on working surface of inner liner where EBC appeared to be intact or only slightly damaged.

BSAS Volatility in Combustion Environment. Specimens were prepared from many EBC areas on both liner surfaces where the EBC appeared fully intact (see Fig. 3b.) Figures 8a and 8b, comparing cross-section SEM images of the Si/mullite/BSAS EBC from the aft end of the inner liner and from an area towards its center, respectively, clearly show a significant loss of the BSAS top coat in the center area of the inner liner. Visual inspection of the liner did not provide any information regarding loss of EBC (BSAS). Figures 9a and 9b show a similar comparison for areas of the outer liner. Varying amounts of BSAS loss via volatilization were measured across the inner and outer liner working surfaces. In general, the thickness of the BSAS reduced gradually from the fore end of the liner, which was close to the original as-processed thickness, towards the liner center and then gradually increased again towards the aft end of the liner. (Note that the top layers of the EBC within ~2cm of the aft end of both the inner and outer liners had spalled off due to mechanical problems with the metallic attachment, which has since been redesigned to avoid the problem.[13]) The different amounts of BSAS recession across the surfaces of the liners can be attributed to temperature variations from the cooler ends of the liners to the center and across the center region of both liners (accurate temperature measurements could not be made on the liners during engine testing but were between 1100-1250°C.)

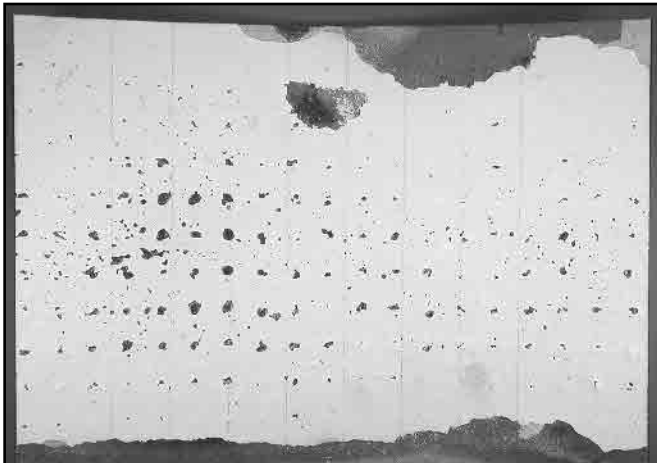
Fig. 3c. "Pinhole" pattern observed on working surface of outer liner.

Surface Asperities and Pinhole Defect Formation. As shown in Fig. 3c, a regular pattern of “pinhole” defects was observed on the working surfaces of both the inner and outer liners, but was especially prevalent across most of the surface of the outer liner. These defects were initially observed during borescope inspections in the early stages of the engine test and increased in number and severity as the engine test progressed. The spacing of the majority of the defects on the outer liner corresponded directly with the tooling used during the CVI processing of the outer liner. The pattern of “tool bumps” are always observed on the surface of as-processed CVI-produced CFCCs and are caused initially by the slight localized pulling or raising of the wound fibrous preform (usually a single fiber tow) during CVI. The tool bumps on the surface of the liner are still evident following the application of the CVD SiC seal coat, as shown in Fig. 15. The surface asperities at this stage usually measure ~0.2-0.25mm in height. After application of the EBC, the surface asperities are still present, as shown on the surface of an as-processed EBC/CVI-CFCC coupon in Fig. 16. A cross-section directly through a typical tool bump shows that in the

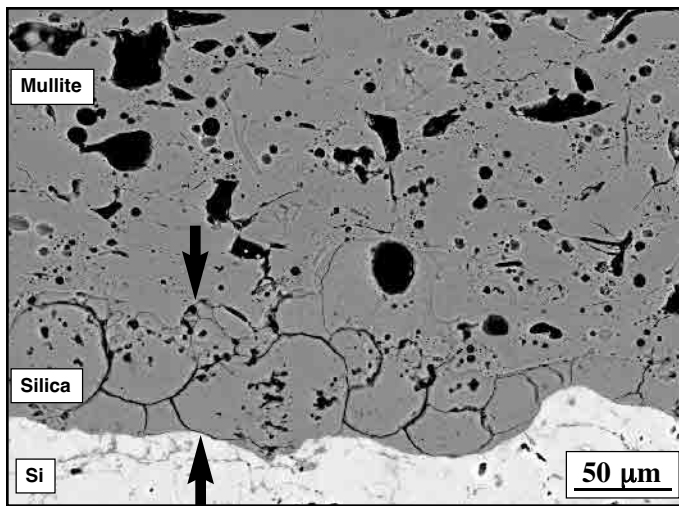
With this in mind, differences in the protective capability of each of the two EBCs became apparent in the early stages of exposure in the Keiser Rig. After 1500h at $1200^\circ C$ and 1.5atm H_2O , imaging the Si/mullite (area circled in Fig. 1) or the Si/(mullite+BSAS) (area circled in Fig. 2) interfaces of the EBC revealed oxidation of the Si bond coat which resulted in the formation of SiO_2 at the interfaces during exposure. Differences between the amount of SiO_2 formed after 1500h for the two EBC formulations are shown in Fig. 4 and Fig. 5 for the Si/mullite/BSAS and Si/(mullite+BSAS)/BSAS mixed-layer EBCs, respectively. Note that the amount of SiO_2 formed in the Si/Mullite/BSAS EBC (Fig. 4) was $\sim 5X$ thicker than that formed in the mixed-layer EBC (Fig. 5) indicating that the protective capability of the mixed-layer EBC was superior. In fact, exposure of the Si/mullite/BSAS EBC/CFCC coupon in the Keiser Rig was suspended after 3000h because excessive oxide formation at the Si/mullite interface led to some EBC spallation at this interface. The primary reason for the greater degree of oxidation for the Si/mullite/BSAS EBC is attributed to excessive micro-cracking and porosity within the mullite intermediate layer after EBC processing. The (mullite+BSAS) intermediate layer in the mixed-layer EBC did not show excessive micro-cracking in the as-processed condition. Exposure of the mixed-layer EBC/CFCC coupon was continued for a total exposure time of 6500h. The Si/(mullite+BSAS) interface in the mixed-layer EBC/CFCC after 5000h at $1200^\circ C$ and 1.5atm H_2O is shown in Fig. 6. A comparison of Fig. 5 and Fig. 6 shows only slow thickening of the SiO_2 at extended times, further demonstrating the superiority of this EBC compared to the Si/mullite/BSAS EBC.

Fig. 4. SEM image of SiO_2 formed at Si/mullite interface ($\sim 50\mu\text{m}$ thick) in standard 3-layer EBC after 1500h at 1200°C and $1.5\text{atm H}_2\text{O}$.

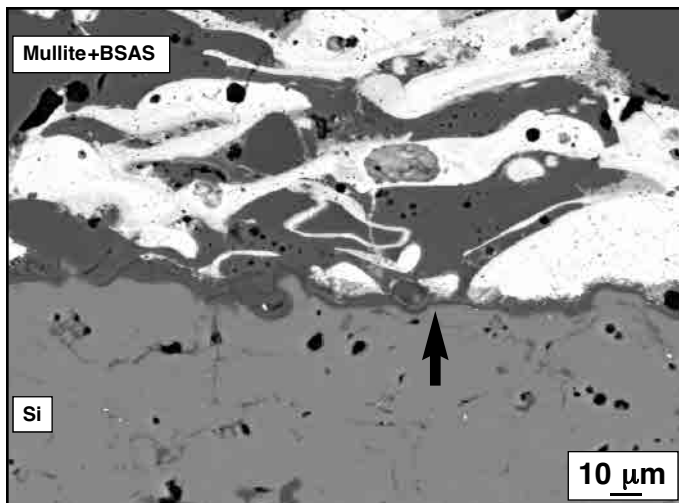
Fig. 5. SEM image of SiO_2 formed at Si/(mullite+BSAS) interface ($<10\mu\text{m}$) in mixed-layer EBC after 1500h at 1200°C and $1.5\text{atm H}_2\text{O}$.

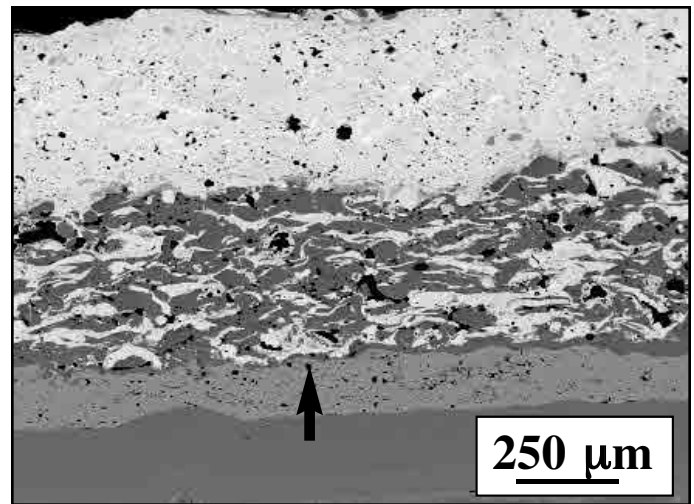
Fig. 6. SEM image of SiO_2 formed at Si/(mullite+BSAS) interface ($\sim 20\mu\text{m}$) in mixed-layer EBC after 5000h at 1200°C and $1.5\text{atm H}_2\text{O}$.

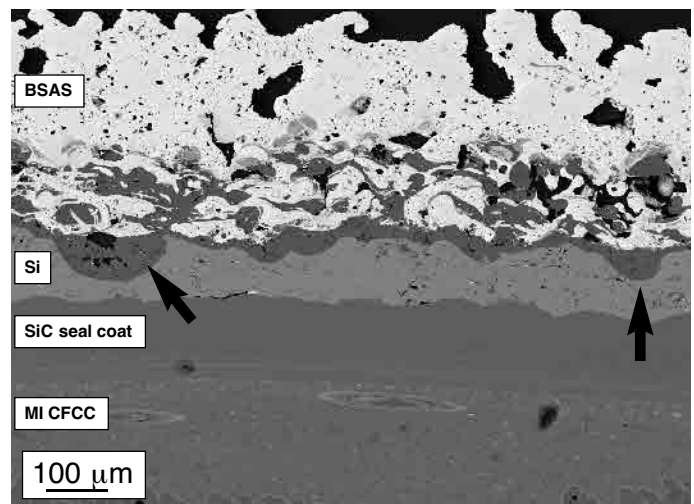
The EBC processing parameters were adjusted in the early stages of this work to minimize the number of processing defects (such as through-thickness cracks) on the final EBC/CFCC liners. However, even under the best processing conditions, some processing defects were still found. When these defects were present, accelerated localized oxidation below the EBC was observed, as shown in Fig. 7. Silica formation (Si oxidation) was excessive in these areas.

Fig. 7. SEM image of accelerated SiO_2 formation associated with processing defects (excess porosity) in mixed-layer EBC after 5000h at 1200°C and $1.5\text{atm H}_2\text{O}$.

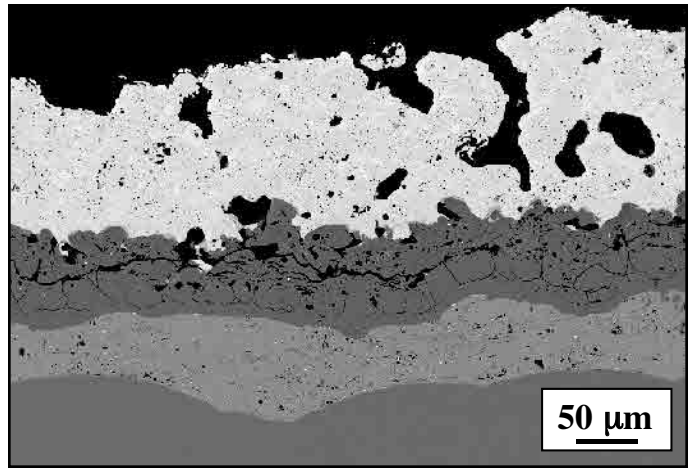
Fig. 8a. SEM image of EBC near aft end of inner liner after engine test (thickness of EBC is close to that of as-processed EBC).

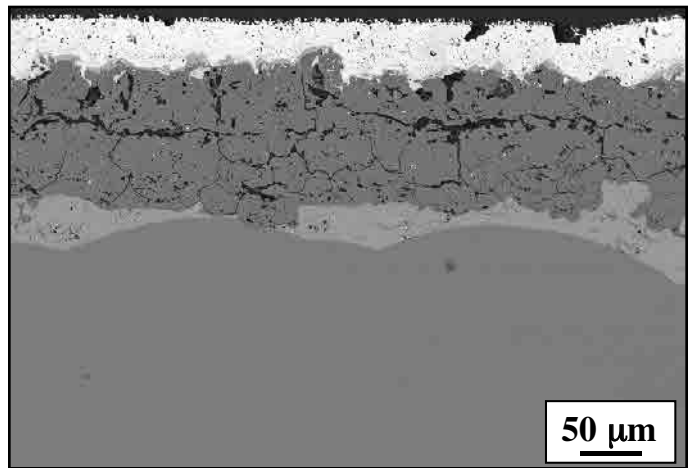
Fig. 8b. SEM image of EBC near center of inner liner after engine testing in an area that appeared to have EBC fully intact but BSAS top coat had recessed to ~75% of its original thickness.

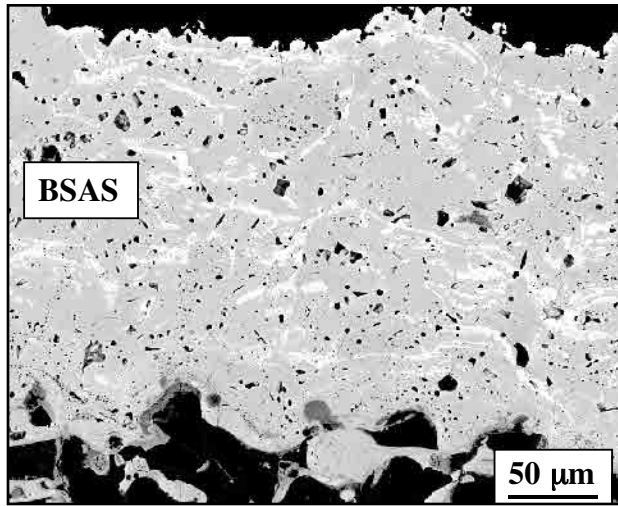
Fig. 9a. SEM image of EBC near aft end of outer liner after engine test (thickness of EBC is close to that of as-processed EBC).

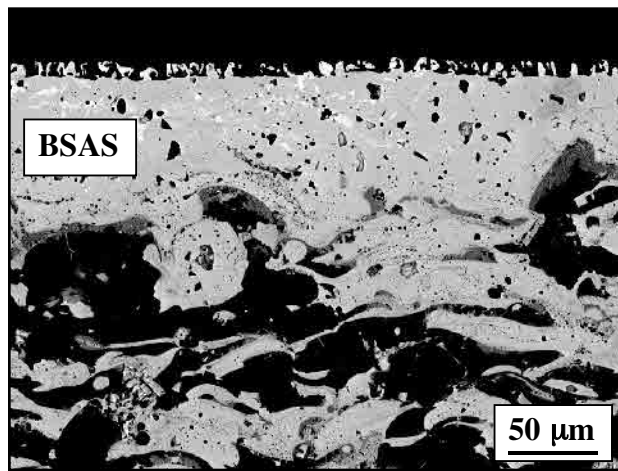
Fig. 9b. SEM image of EBC near center of outer liner after engine testing in an area that appeared to have EBC fully intact but BSAS top coat had recessed to ~60% of its original thickness.

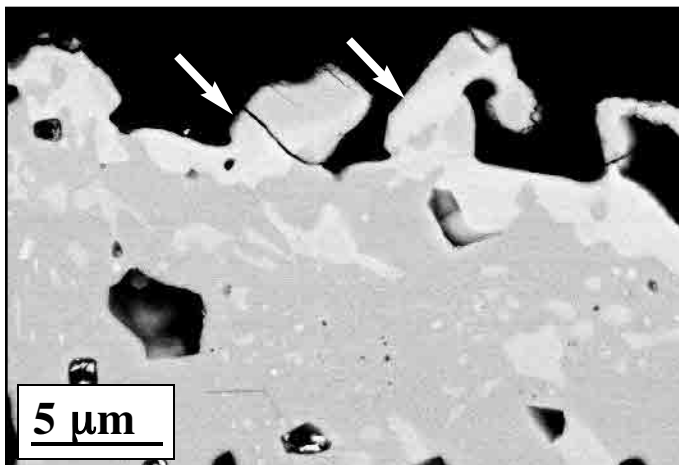
A high magnification SEM image of the surface of the BSAS which had experienced some volatilization is shown in Figure 10. A residual phase was observed on the surface which was clearly more resistant to volatilization (brightly imaging phase on surface.) This phase, a Sr-rich phase identified as $\text{Sr}_2\text{Al}_2\text{SiO}_7$ by X-ray diffraction, remained on the surface of the top coat longer than the BSAS. This phase has its origins in the as-processed BSAS top coat. As shown in Fig. 11, the as-processed BSAS top coat is a two-phase structure composed of the matrix BSAS celsian phase (standard composition 31.5wt% Ba, 4.7% Sr, 15.6% Al, 15.9% Si, and 32.3% O) and another discontinuous, Sr-enriched, "minor" phase with a composition of ~29.7wt% Ba, 13.6% Sr, 18.5% Al, 8.3% Si, and 29.9% O. This phase could not be identified by X-ray diffraction but was crystalline (as determined by electron diffraction.) Since the silica within the BSAS likely contributed to the BSAS volatilization observed during engine testing, less SiO_2 present in the starting and final Sr-rich phases made this a more stable phase. Thus, a key to improving the durability of the top coat for use in this application could be to take advantage of the presence of a Sr-rich phase.

Fig. 10. High magnification image of the surface of a partially volatilized BSAS top coat after engine testing showing $\text{Sr}_2\text{Al}_2\text{SiO}_7$ phase (brightly imaging phase) residing on top coat surface.

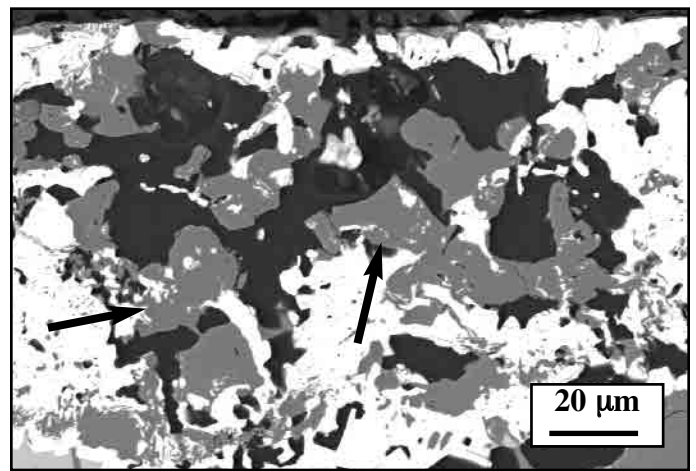
Stability of Mullite in Combustion Environments. In many areas where the BSAS top coat had significantly or completely recessed, the mullite intermediate layer was affected considerably. Once exposed to the combustion environment, the mullite rapidly separated into Al_2O_3 and SiO_2 . The SiO_2 subsequently volatilized leaving behind a porous, completely non-protective layer. This occurred on the inner and outer liner for both the Si/mullite/BSAS and the mixed-layer Si/(mullite+BSAS)/BSAS EBCs. Figure 12 shows an image of the outer liner where the BSAS completely volatilized exposing the mixed intermediate layer (mullite+BSAS) to the combustion environment. The mullite within the mixed layer has started to decompose into SiO_2 and Al_2O_3 (the Al_2O_3 forms around the edges of the mullite, designated by arrows in Fig. 12). The SiO_2 areas have volatilized leaving behind large pores in the layer, rendering the layer non-protective.

Fig. 12. SEM image of mixed mullite+BSAS layer in an area on outer liner where BSAS top coat had fully recessed during engine testing. Arrows denote pure Al_2O_3 .

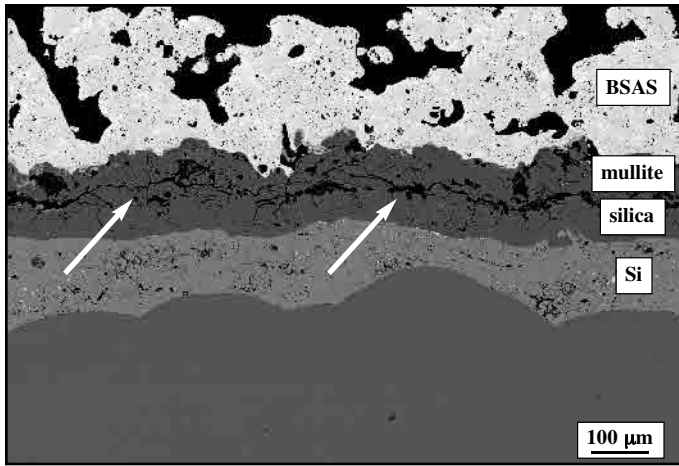
Oxidation Of Si Bond Coat Within EBCs. In areas on both the inner and outer liner surfaces where the EBC was fully intact (usually close to the aft or fore ends of liner), oxidation of the Si bond coat was consistently observed. These results were consistent with observations made on similarly processed EBC/CFCC coupons exposed in ORNL's Keiser Rig. Figure 13 shows a region on the inner liner surface near the aft end where the Si/mullite/BSAS standard EBC was intact. Extensive oxidation of the Si bond coat was observed, as evidenced by SiO_2 formation. Associated with these regions were other areas where EBC spallation was observed. Spallation of the BSAS top coat and mullite layer consistently occurred between the SiO_2 layer and mullite intermediate layer (Note separation between these layers in Fig. 13). Figure 14 shows an SEM image of the Si/(mullite+BSAS)/BSAS mixed-layer EBC from the outer liner close to the aft end of the liner. In this case, the EBC imparted greater protection for the underlying constituents and oxidation of the Si bond coat was minimized and was similar to that predicted by Keiser Rig exposures conducted at 1200°C and 1.5 atm H_2O (see Fig. 6).

Fig. 13. SEM image of EBC on inner liner near aft end showing extensive oxidation of Si bond coat. Spallation consistently occurs between SiO_2 and mullite (arrows).

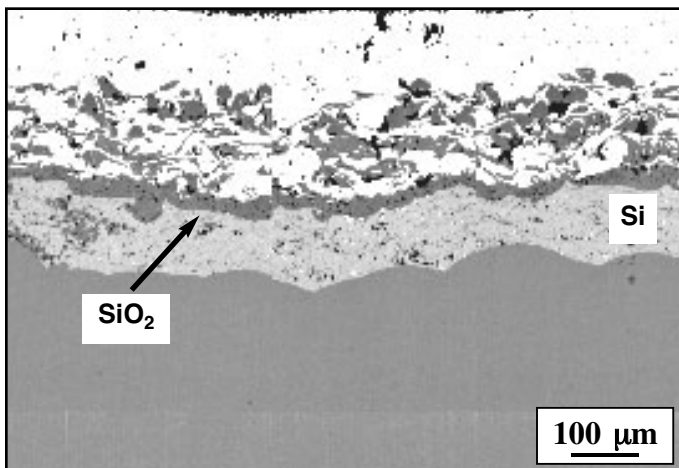
Fig. 14. SEM image of mixed-layer EBC on outer liner near aft end showing minimum oxidation of Si bond coat after ~14,000h engine test consistent with results of Keiser Rig exposures.

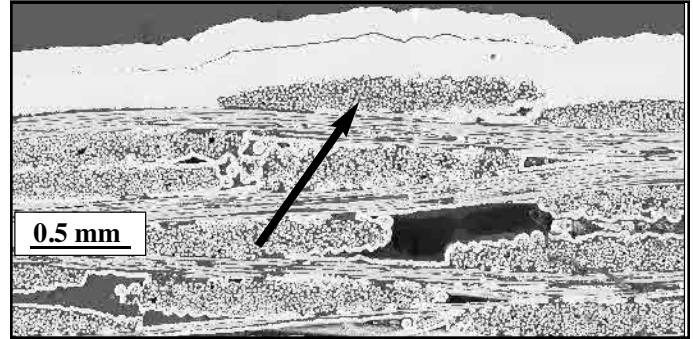
Fig. 15. Cross-section SEM image through a tool-bump after CVD SiC seal coat application. Note raised fiber tow.

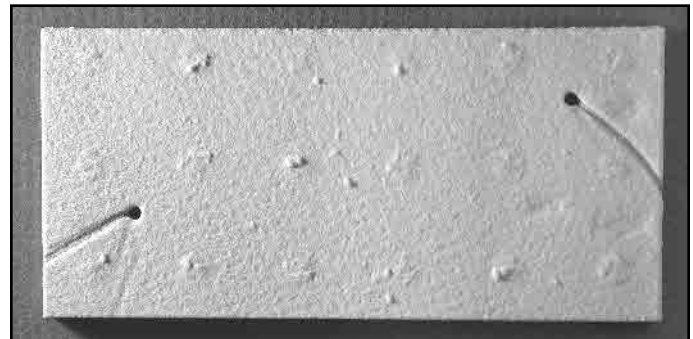
Fig. 16. CVI SiC/SiC coupon after EBC is applied showing obvious surface asperities due to tool bumps.

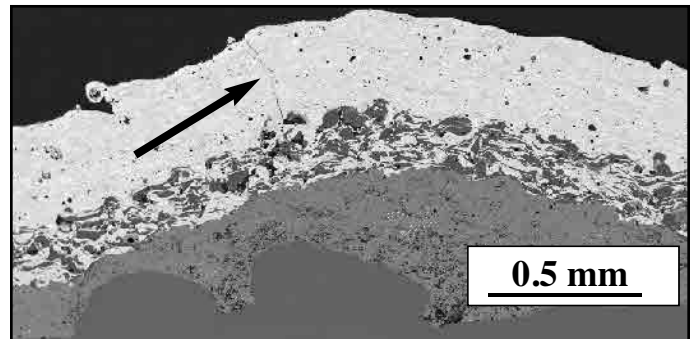
majority of cases, the asperity results in the formation of a through-thickness crack in the EBC, as shown in Fig. 17. Clearly, a through-thickness crack in the EBC will lead to localized accelerated oxidation of the Si bond coat below the surface. In fact, rapid oxidation of the constituents below the surface caused these localized areas to oxidize at rates approaching those of the uncoated CFCCs and severely limited the lifetime of the liner. Figure 18 shows a tool bump area from a relatively cool section (fore end) of the outer liner. In this case, the formation of excessive SiO_2 just below the EBC nearly resulted in the spallation of the EBC. Oxidation did not progress through the CVD SiC seal coat and into the CFCC. However, in much hotter areas near the center of the outer liner, pinholes formed when the rapid oxidation progressed down through the Si bond coat, the CVD SiC, and well into the CFCC, as shown in Fig. 19. In several cases, localized loss of the entire liner thickness resulted from the accelerated oxidation associated with the tool bumps.

Fig. 17. Cross-section SEM image through a tool bump area showing a through-thickness crack associated with a bump.

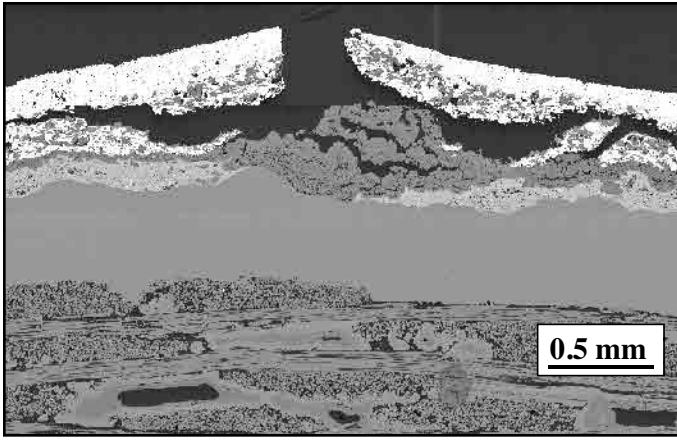
Fig. 18. Cross-section SEM image through a tool bump from fore end (cooler) of outer liner.

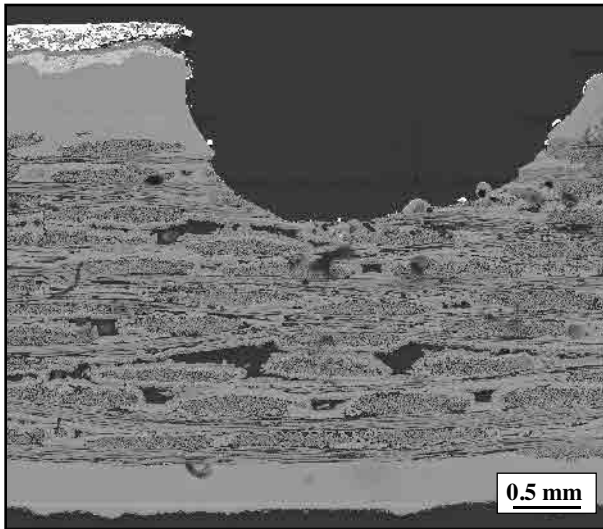
Fig. 19. Cross-section SEM image through a "pinhole" defect formed from a tool bump near center of outer liner.
